Re: Vernell B. Morris Case

The following is a summary of the activities and results to date in the reconstruction of the September 02, 2004 accident involving Vernel B. Morris, driving a 1998 Kenworth tractor and Edward N. Thompson, driving a 1995 Peterbilt tractor. The accident occurred on Interstate 85 northbound, between Macon County Road 30 and Macon County Road 93, in Macon County, Alabama.

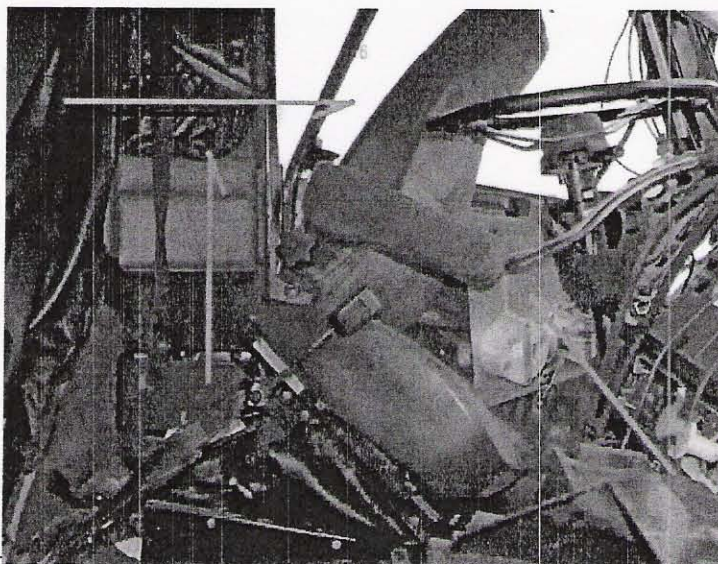
CARTESIAN COORDINATES

Upon inspection of the cab of the 1998 Kenworth, the driver seat was observed to be pushed up (from the floor) and forward toward the steering wheel, that is, deformation was experienced along the negative z axis (upwards, relative to the normal upright position of the truck) and along the positive x-axis (the normal forward direction of travel), and also along the negative y-axis (toward the left, or driver side of the truck). Photo #3 depicts the position of the driver seat when it was inspected, and a Cartesian coordinate system for reference.

The position of the seat and the fact that the deformation is most severe in the negative z and positive x directions shows clearly that the deformation is undoubtedly the result of the collision between the two trucks, not the result of the rollover experienced by the Kenworth just prior to the collision. The position of the seat corresponds to the pattern of injury documented by the Alabama Department of Forensic Sciences. According to the Autopsy Report, bruising was located at the anterior chest wall and lower abdominal wall, fractures of ribs #1-5 on the right, and ribs #1-7 on the left. Also noted was a lacerated spleen and bruising to the left arm and shoulder. These injuries are consistent with the belted driver being in the seat when the vehicle collision occurred. It therefore appears more probable than not that Mr. Morris would have been alive until the occurrence of the very severe impact that knocked the cab of the Kenworth tractor off its frame.
